REPORT NO. 96-13

NEW MANUFACTURERS OF
WOODEN PALLETS UTILIZING
MECHANICAL NAILERS
MIL-STD-1660 TESTS

Prepared for:
U.S. Army Armament Research, Development
and Engineering Center
ATTN: AMSTA-AR-ESK
Rock Island, IL 61299-7300

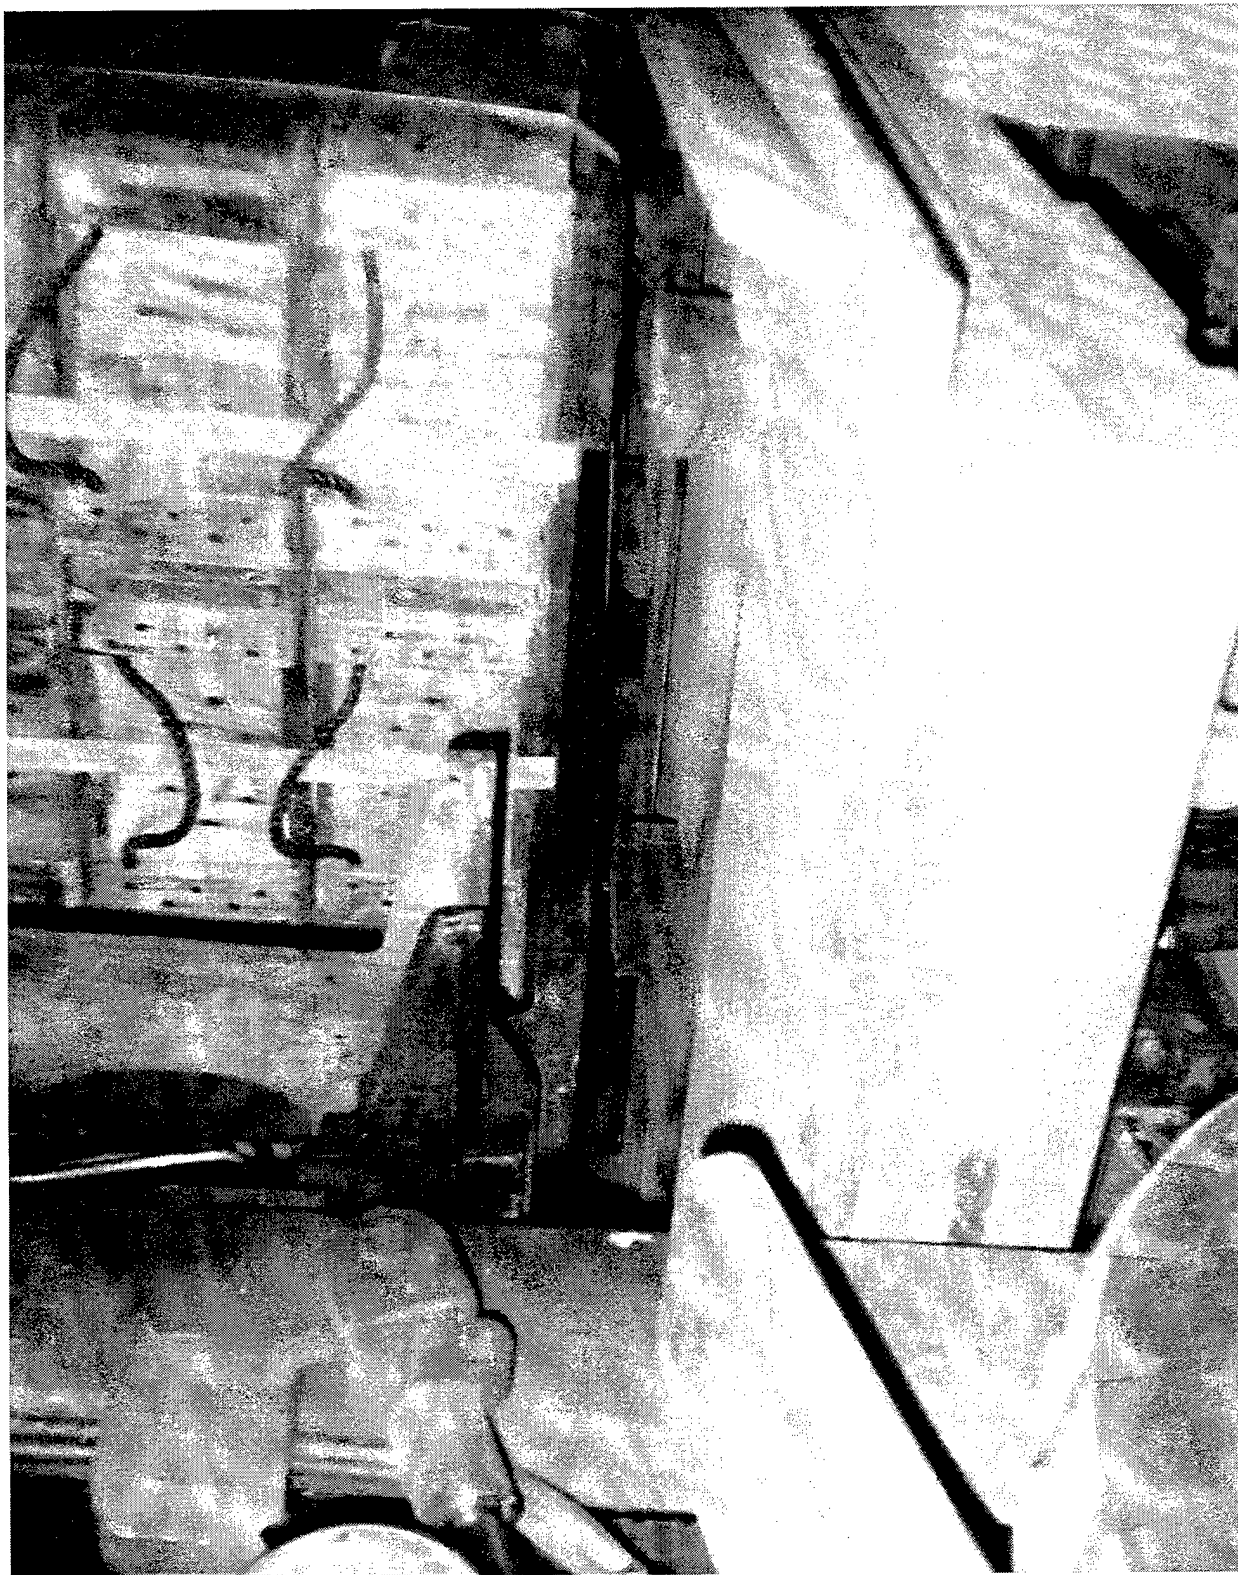
U.S. ARMY DEFENSE AMMUNITION CENTER AND SCHOOL - SAVANNA, IL	
	USADACS-DEV-96-13-01. This photo shows Madison County Wood Products, Inc. pallet no. 2 on the vibration table. The front skid came loose from the deck.

F. END OF TEST INSPECTION. Pallet no. 1 completed testing with only one post twisted. The damage to pallets nos. 2 and 3 was severe enough to discontinue testing following the repetitive shock test. Pallet no. 2 had the nails fastening the deck to one post of the other outside skid shear off. No additional damage was noted on pallet no. 3.

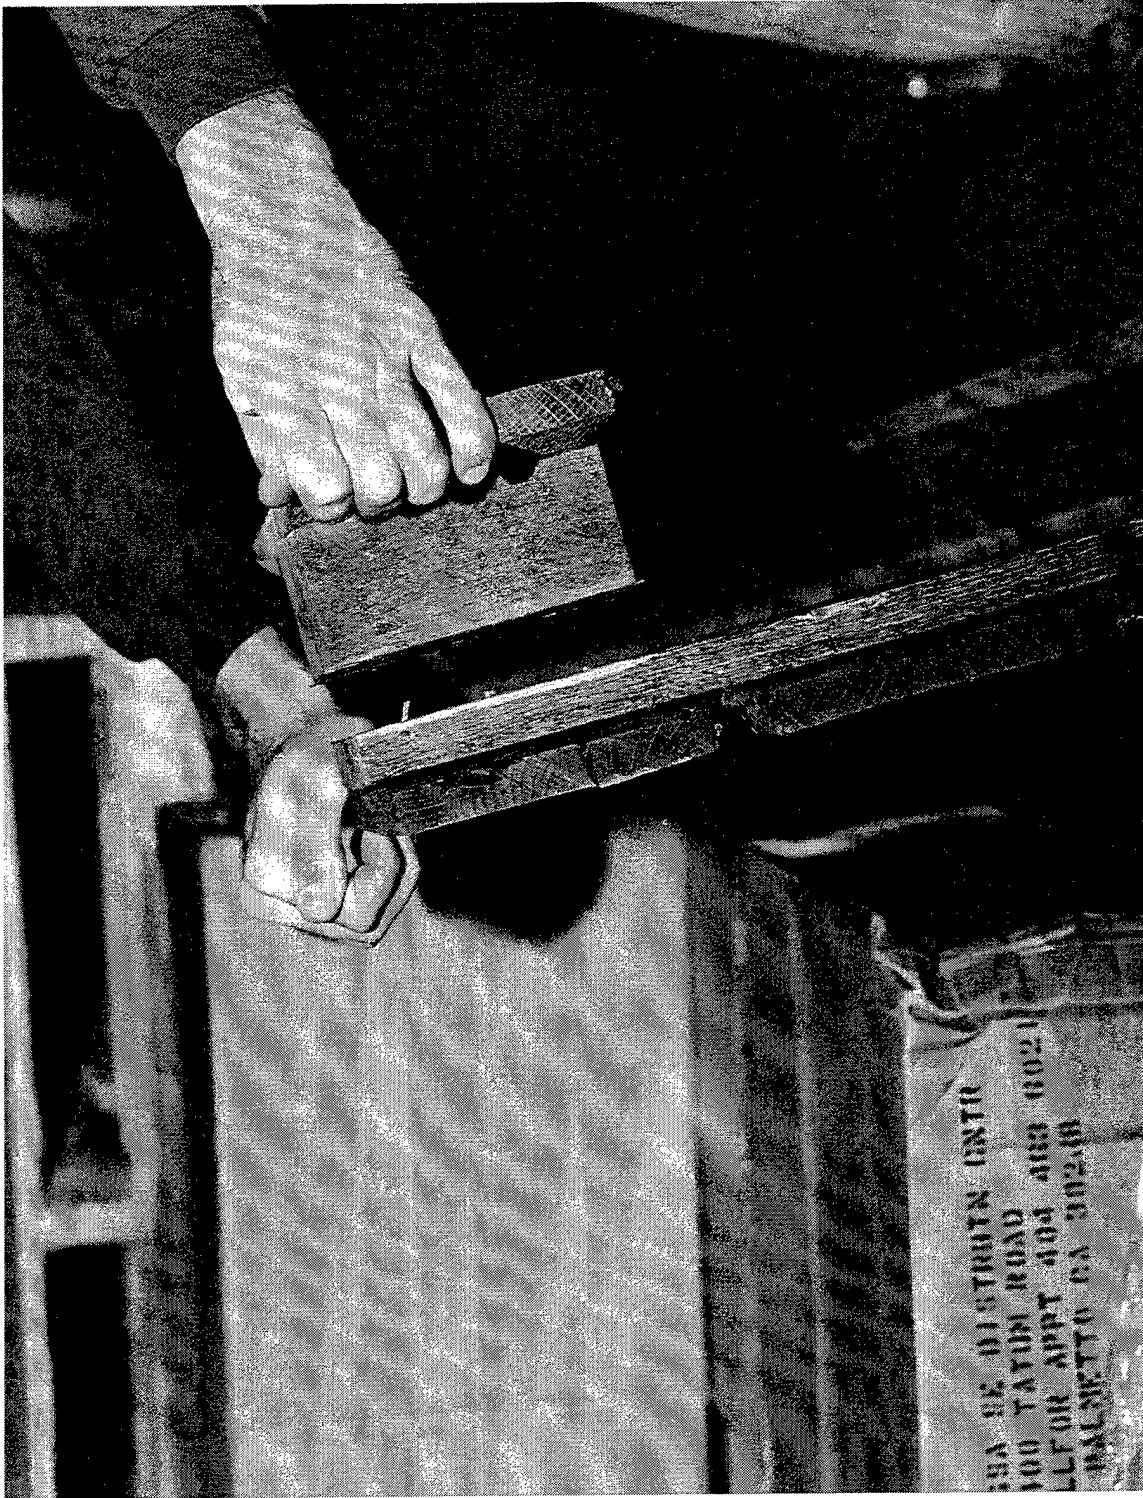
U.S. ARMY DEFENSE AMMUNITION CENTER AND SCHOOL - SAVANNA, IL	
AO317-SCN96-37-834. This photo shows the nails attaching the deck to the post sheared off causing one corner of Madison County Wood Products, Inc. pallet no. 3 to become loose.

C. REPETITIVE SHOCK TEST. The duration of the test was 90 minutes for each orientation of the pallet. The transportation simulator was operated for each pallet IAW Table 1 on page 5-2. One steel strap on pallet no. 1 broke from rubbing against the bar that holds the pallet on the vibration table. The band was replaced and testing was continued. One of the corner posts on pallet no. 1 was twisted slightly while the pallet was being removed from the transportation simulator. The lateral orientation of vibration for pallet no. 2 caused one of the outside skids to release from the posts completely, as 7 of the 9 nails fastening the skid to the posts were sheared off (see Part 6, page 6-2). The longitudinal vibration of pallet no. 3 caused one corner of one of the side skids to come loose from the post. The lateral orientation of vibration caused the nails fastening the deck to the post to shear off at one corner of the pallet (see Part 6, page 6-3).

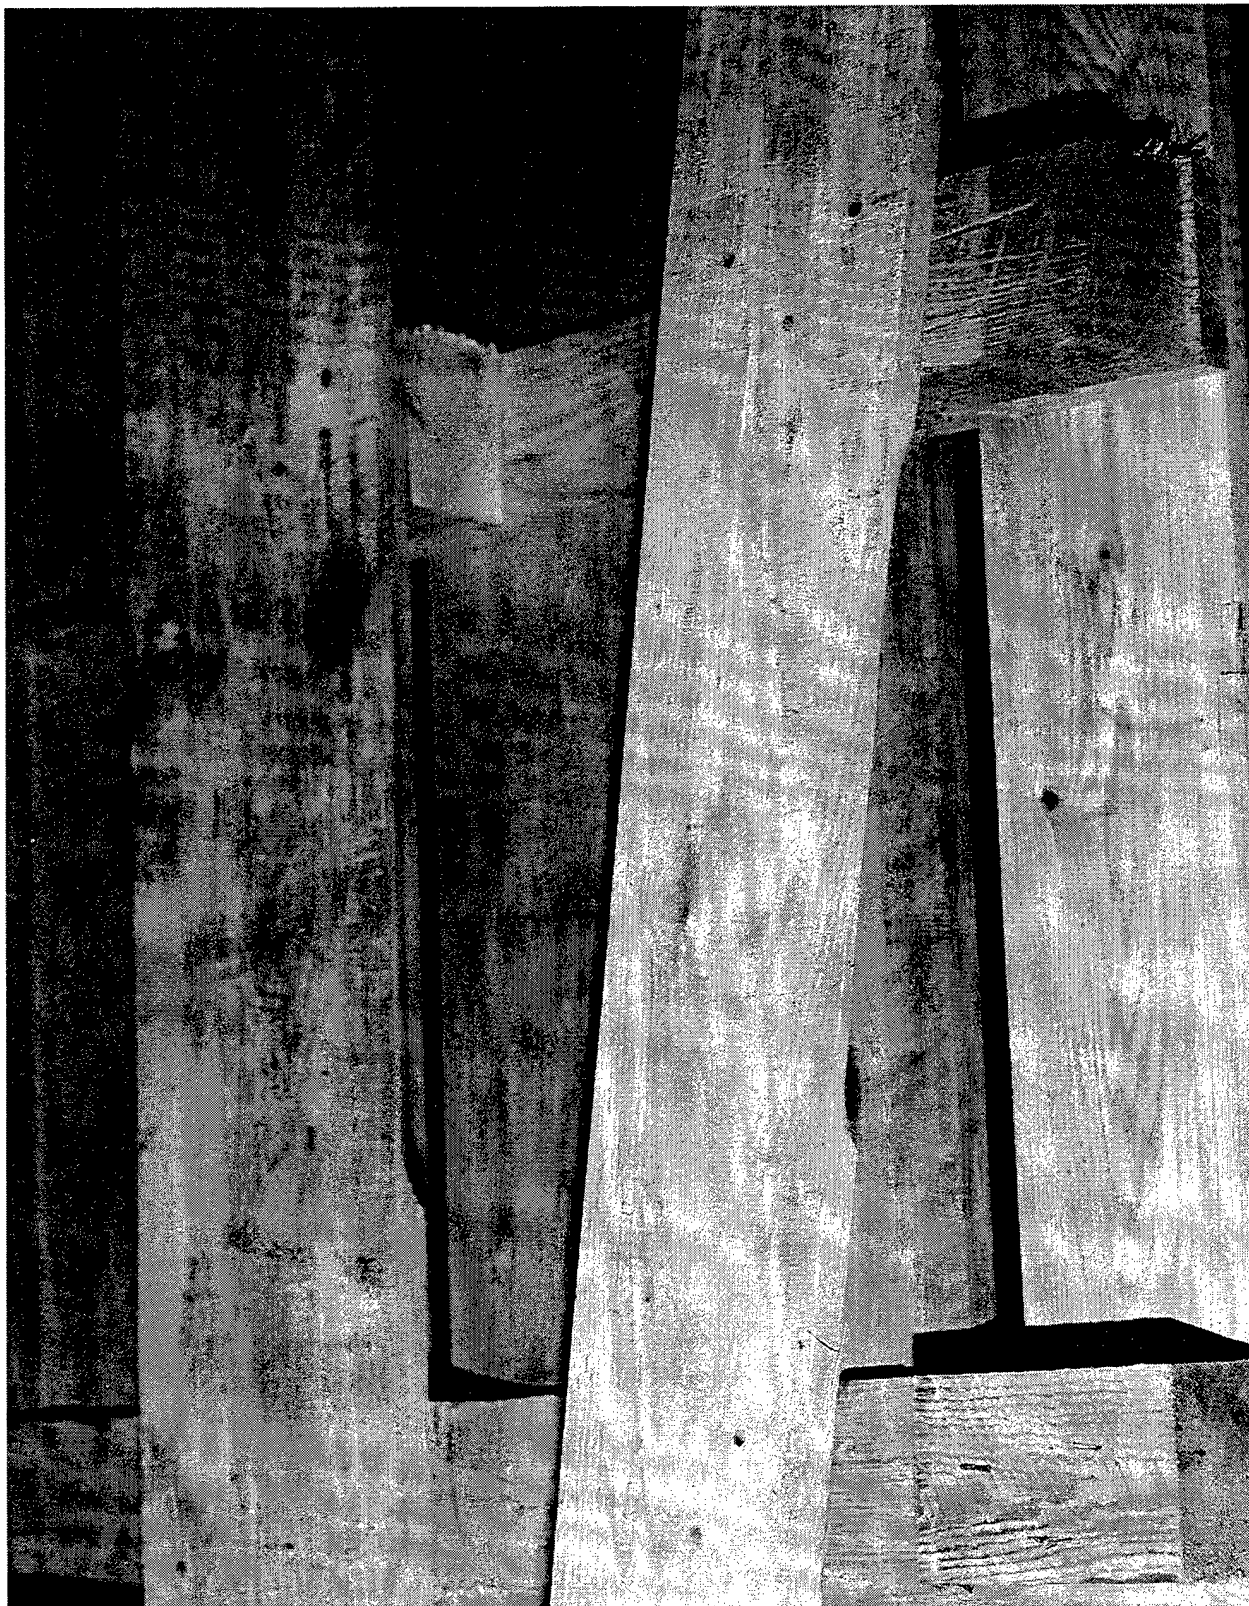
U.S. ARMY DEFENSE AMMUNITION CENTER AND SCHOOL - SAVANNA, IL	
AO317-SCN96-37-836.	This photo shows the detached outside skid of Stewart's Forest Products, Inc. pallet no. 4.

F. END OF TEST INSPECTION. Samples nos. 4 and 5 had nails attaching the skid to the post shear off, causing portions of the pallet to become disassembled. Sample no. 6 completed testing with a slight separation between the deck and the post. The apparent cutting in of the strap in sample no. 6 was a result of the pallet being cracked prior to testing.

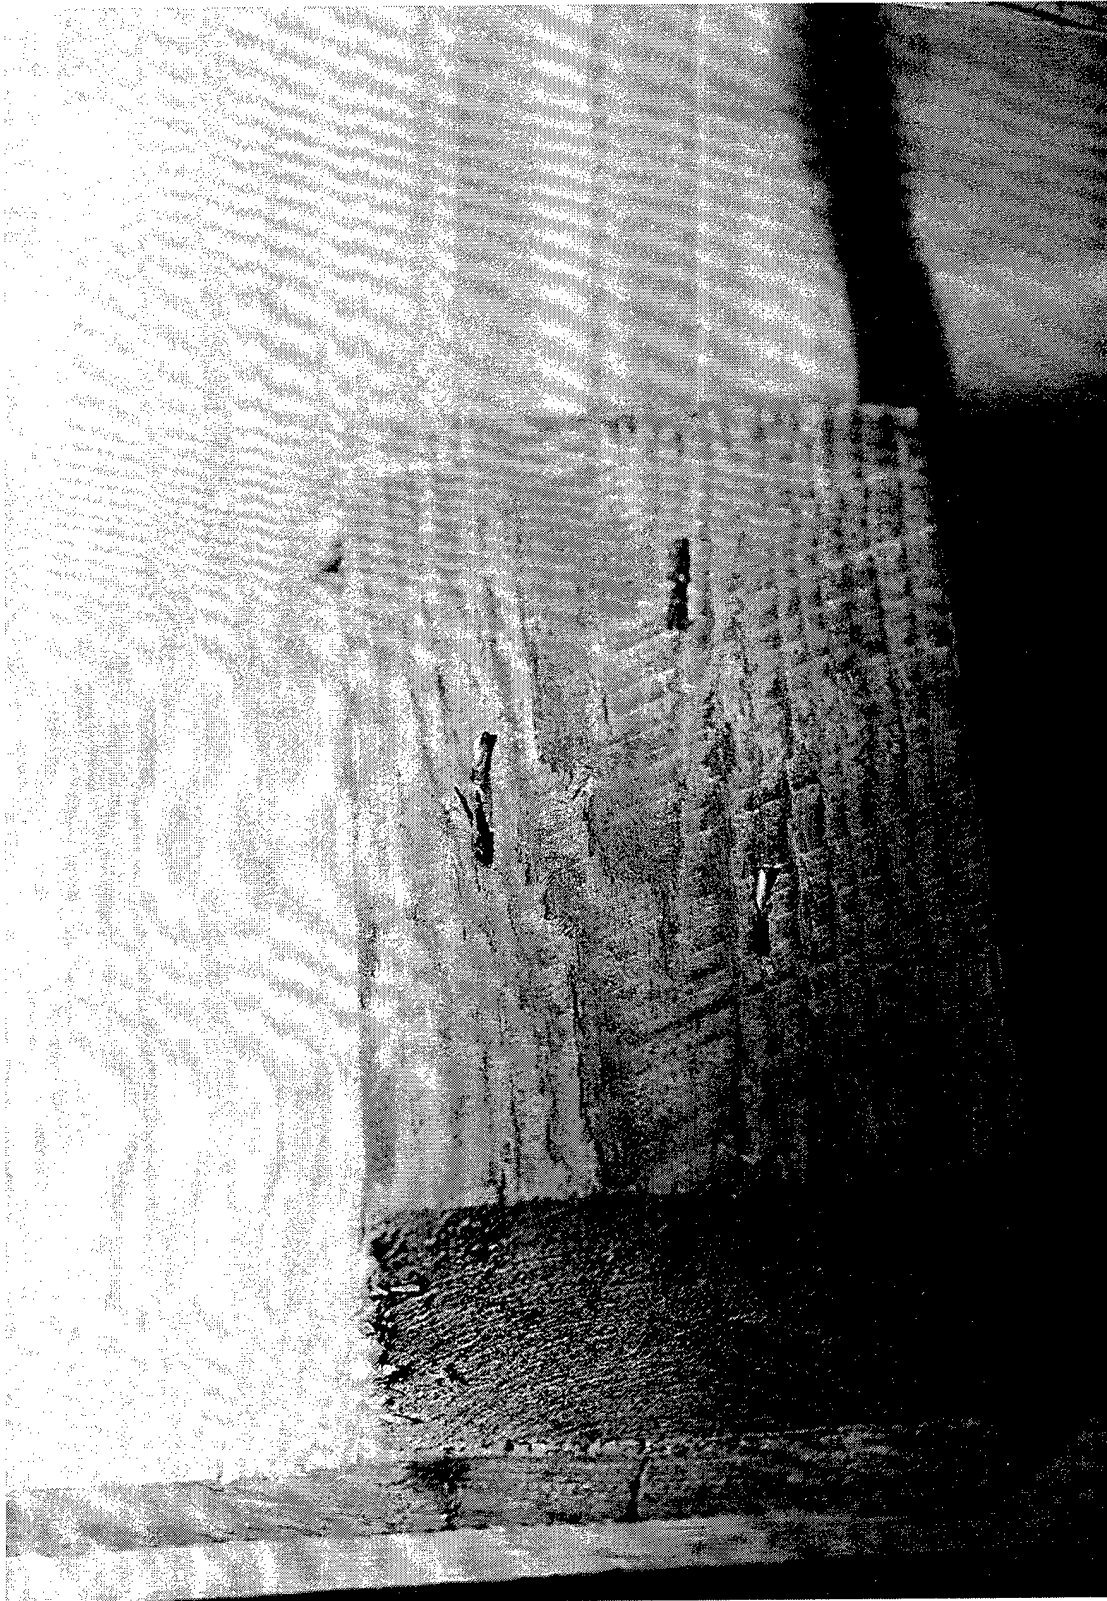
U.S. ARMY DEFENSE AMMUNITION CENTER AND SCHOOL - SAVANNA, IL	
AO317-SCN96-37-837. This photo shows the sheared off nails that attached the skid to the post of Stewart's Forest Products, Inc. pallet no. 4.

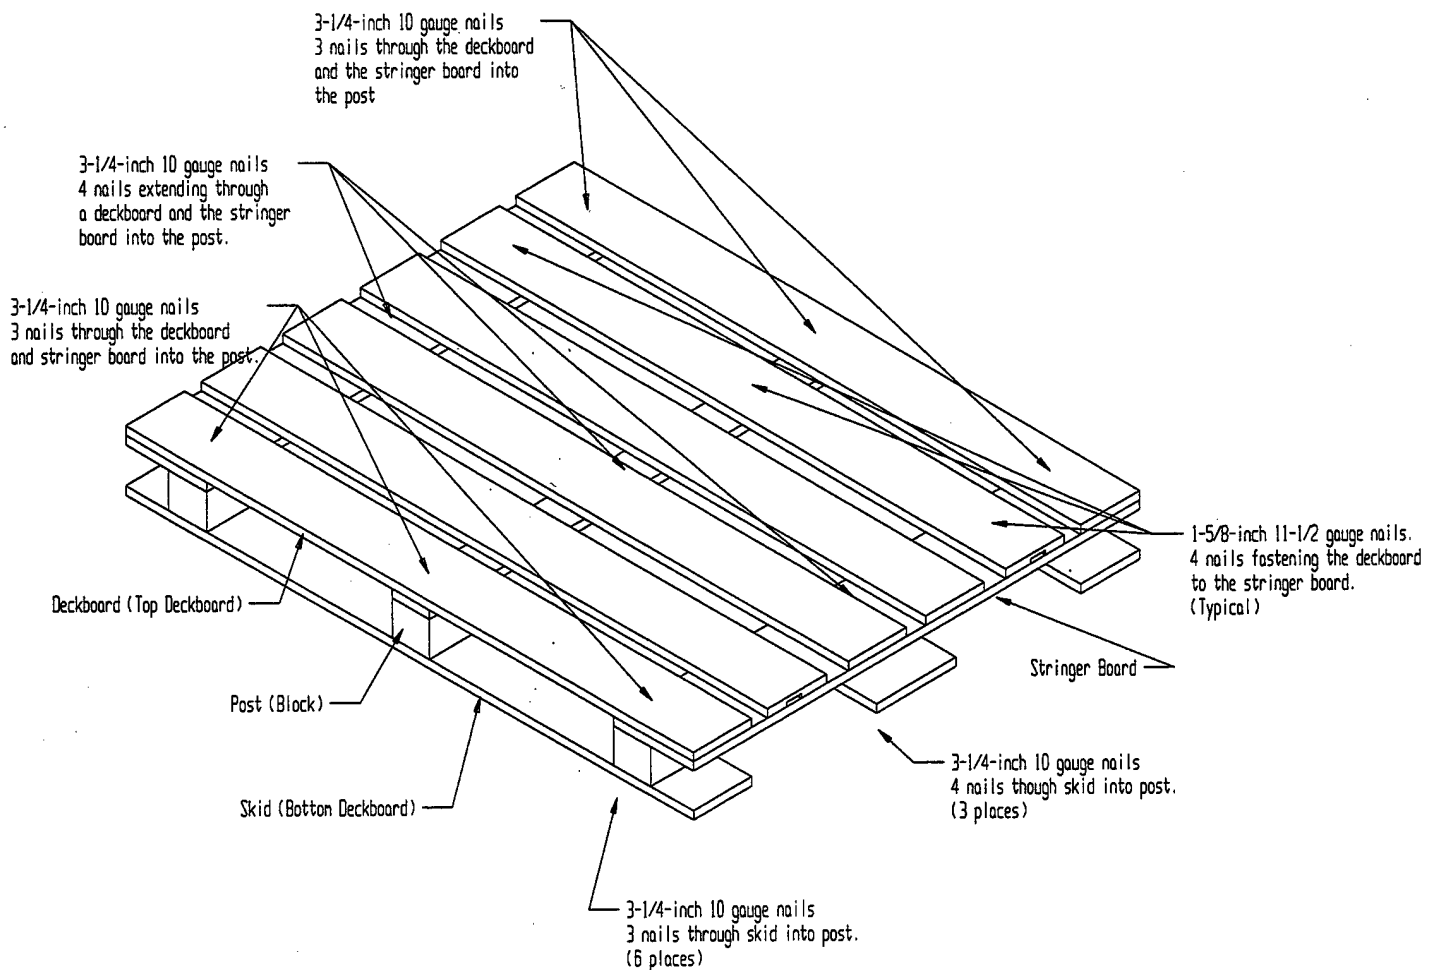
42 Inch X 53 Inch Pallet
 Nails are those used by
 Madison County Wood Products, Inc.

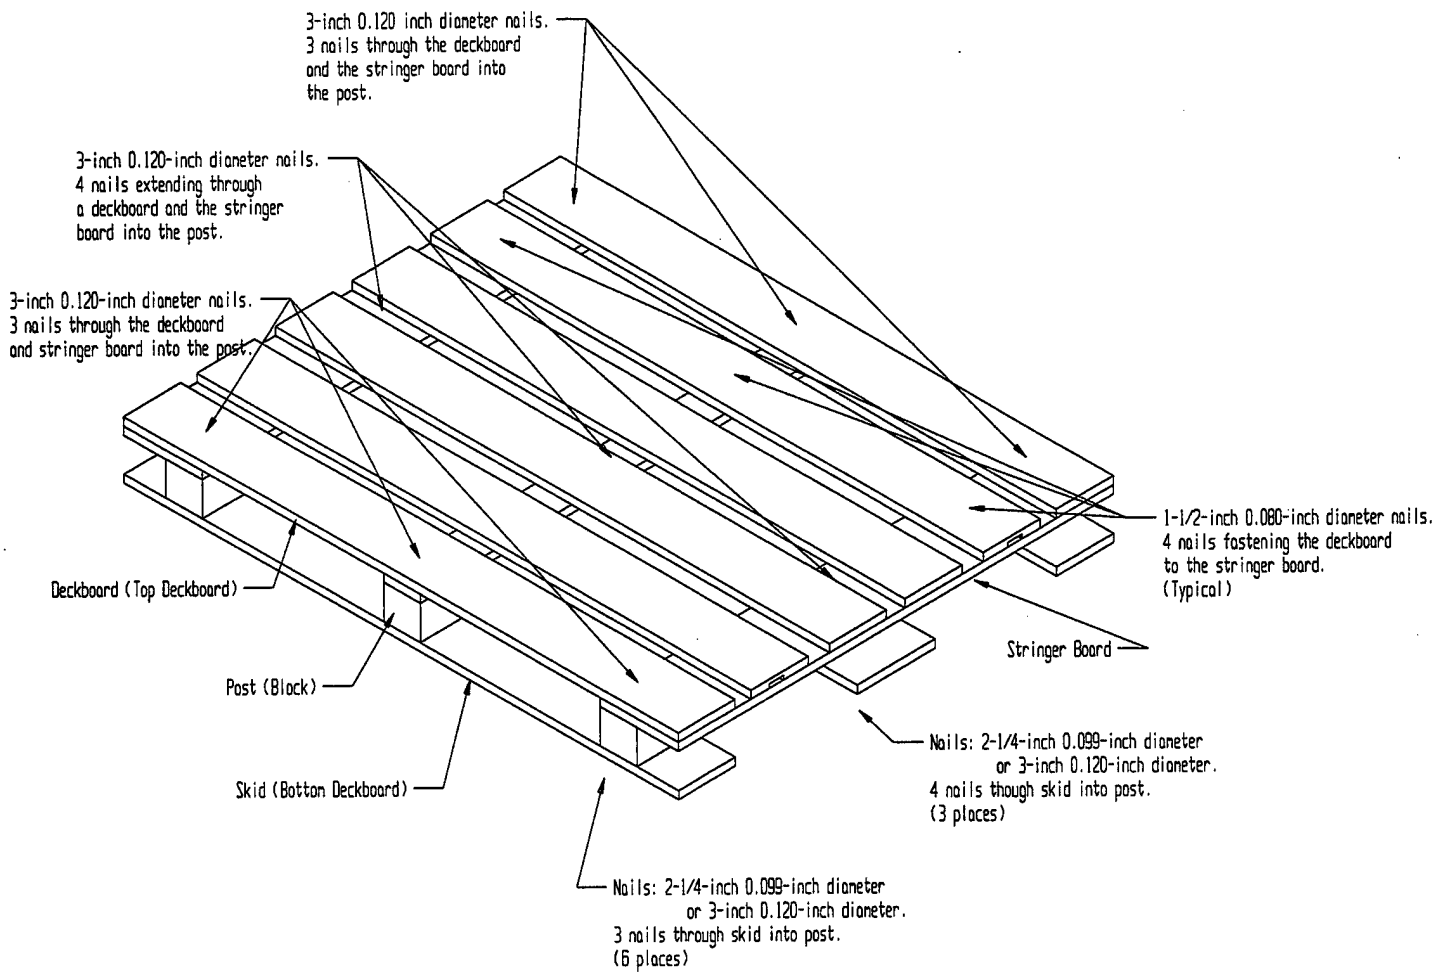
42 Inch X 53 Inch Pallet
Nails are those used by
Stewart's Forest Products, Inc.
